Report on the investigation of a local bump, Brookside

mine, Kentucky Jellico Coal Co., Ky., November 2, 1962,

Coal outbursts in K main section, Brookside mine, Kentucky Jellico Coal Company, Incorporated, Brookside, Harlan County, Kentucky, November 2 and 3, 1962

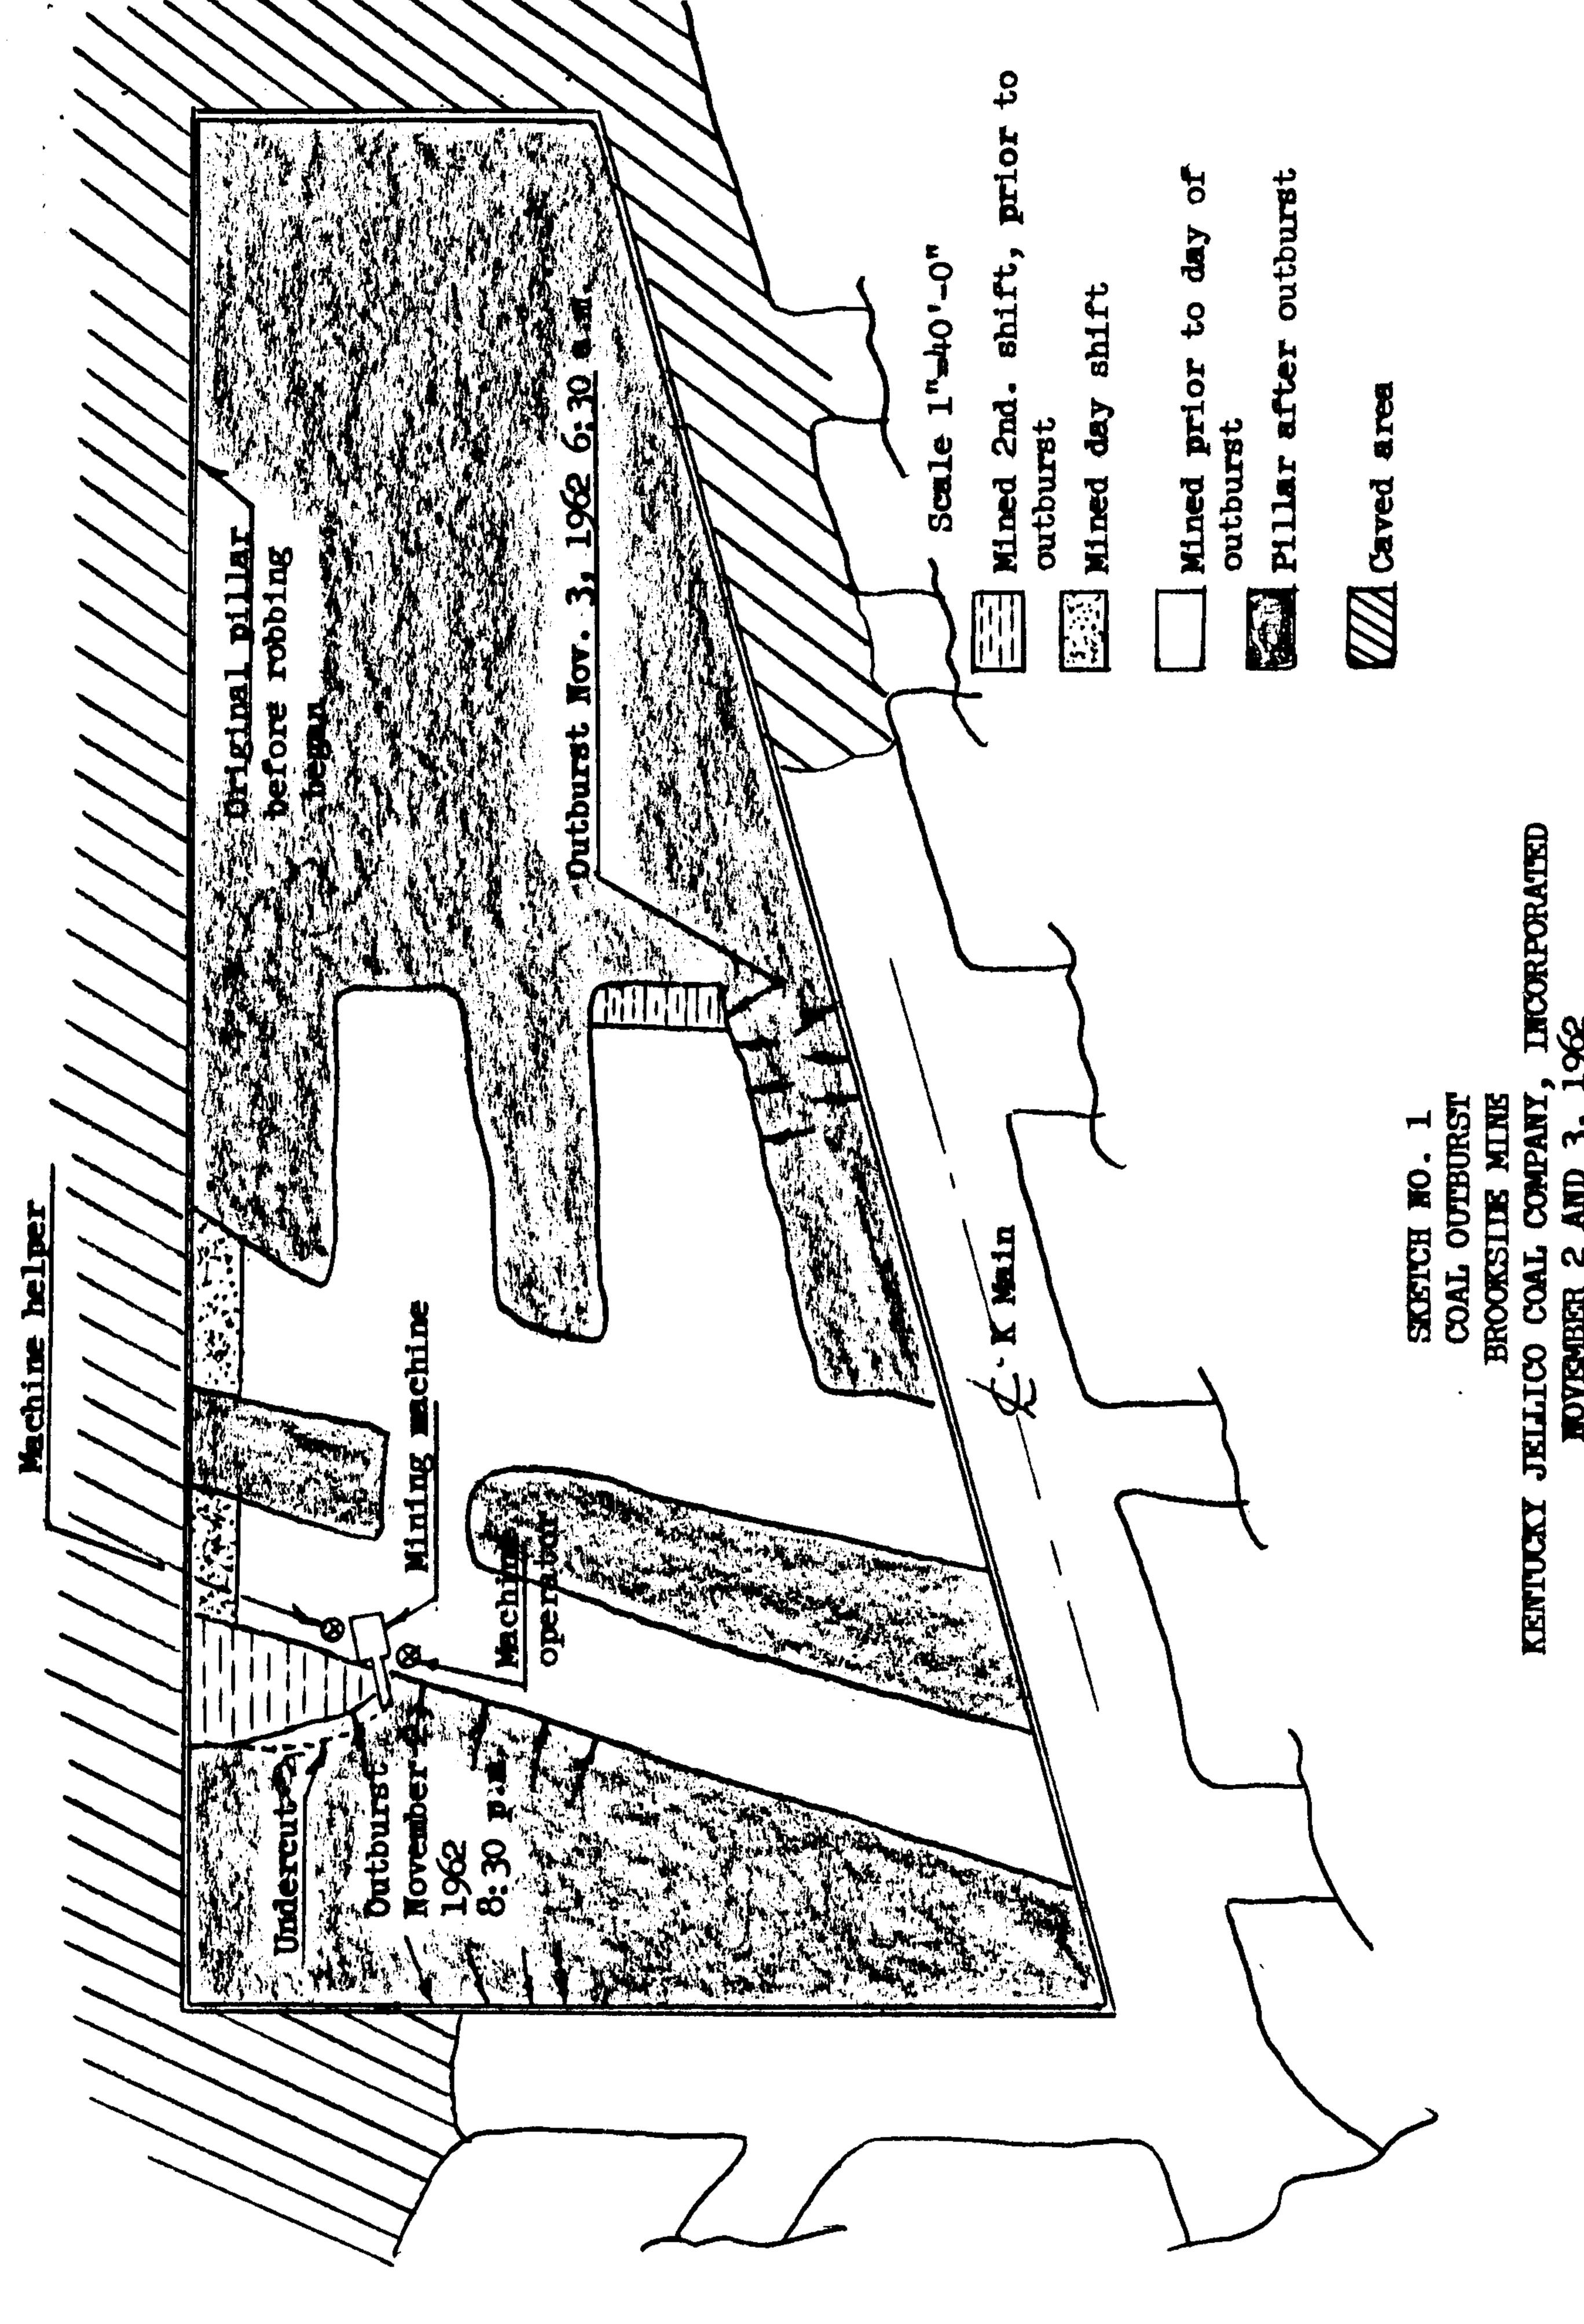
The outbursts were caused by driving splits toward the caved areas in a highly stressed coal pillar. Driving the splits without spads which resulted in forming a large pillar point on the gob end of the remnant was a contributing factor (see sketch No. 1).

2. Pillar splits should not be driven without spads or to excessive widths into a pillar so as to cause the pillar to be "pushed out" instead of being extracted from the gob side.

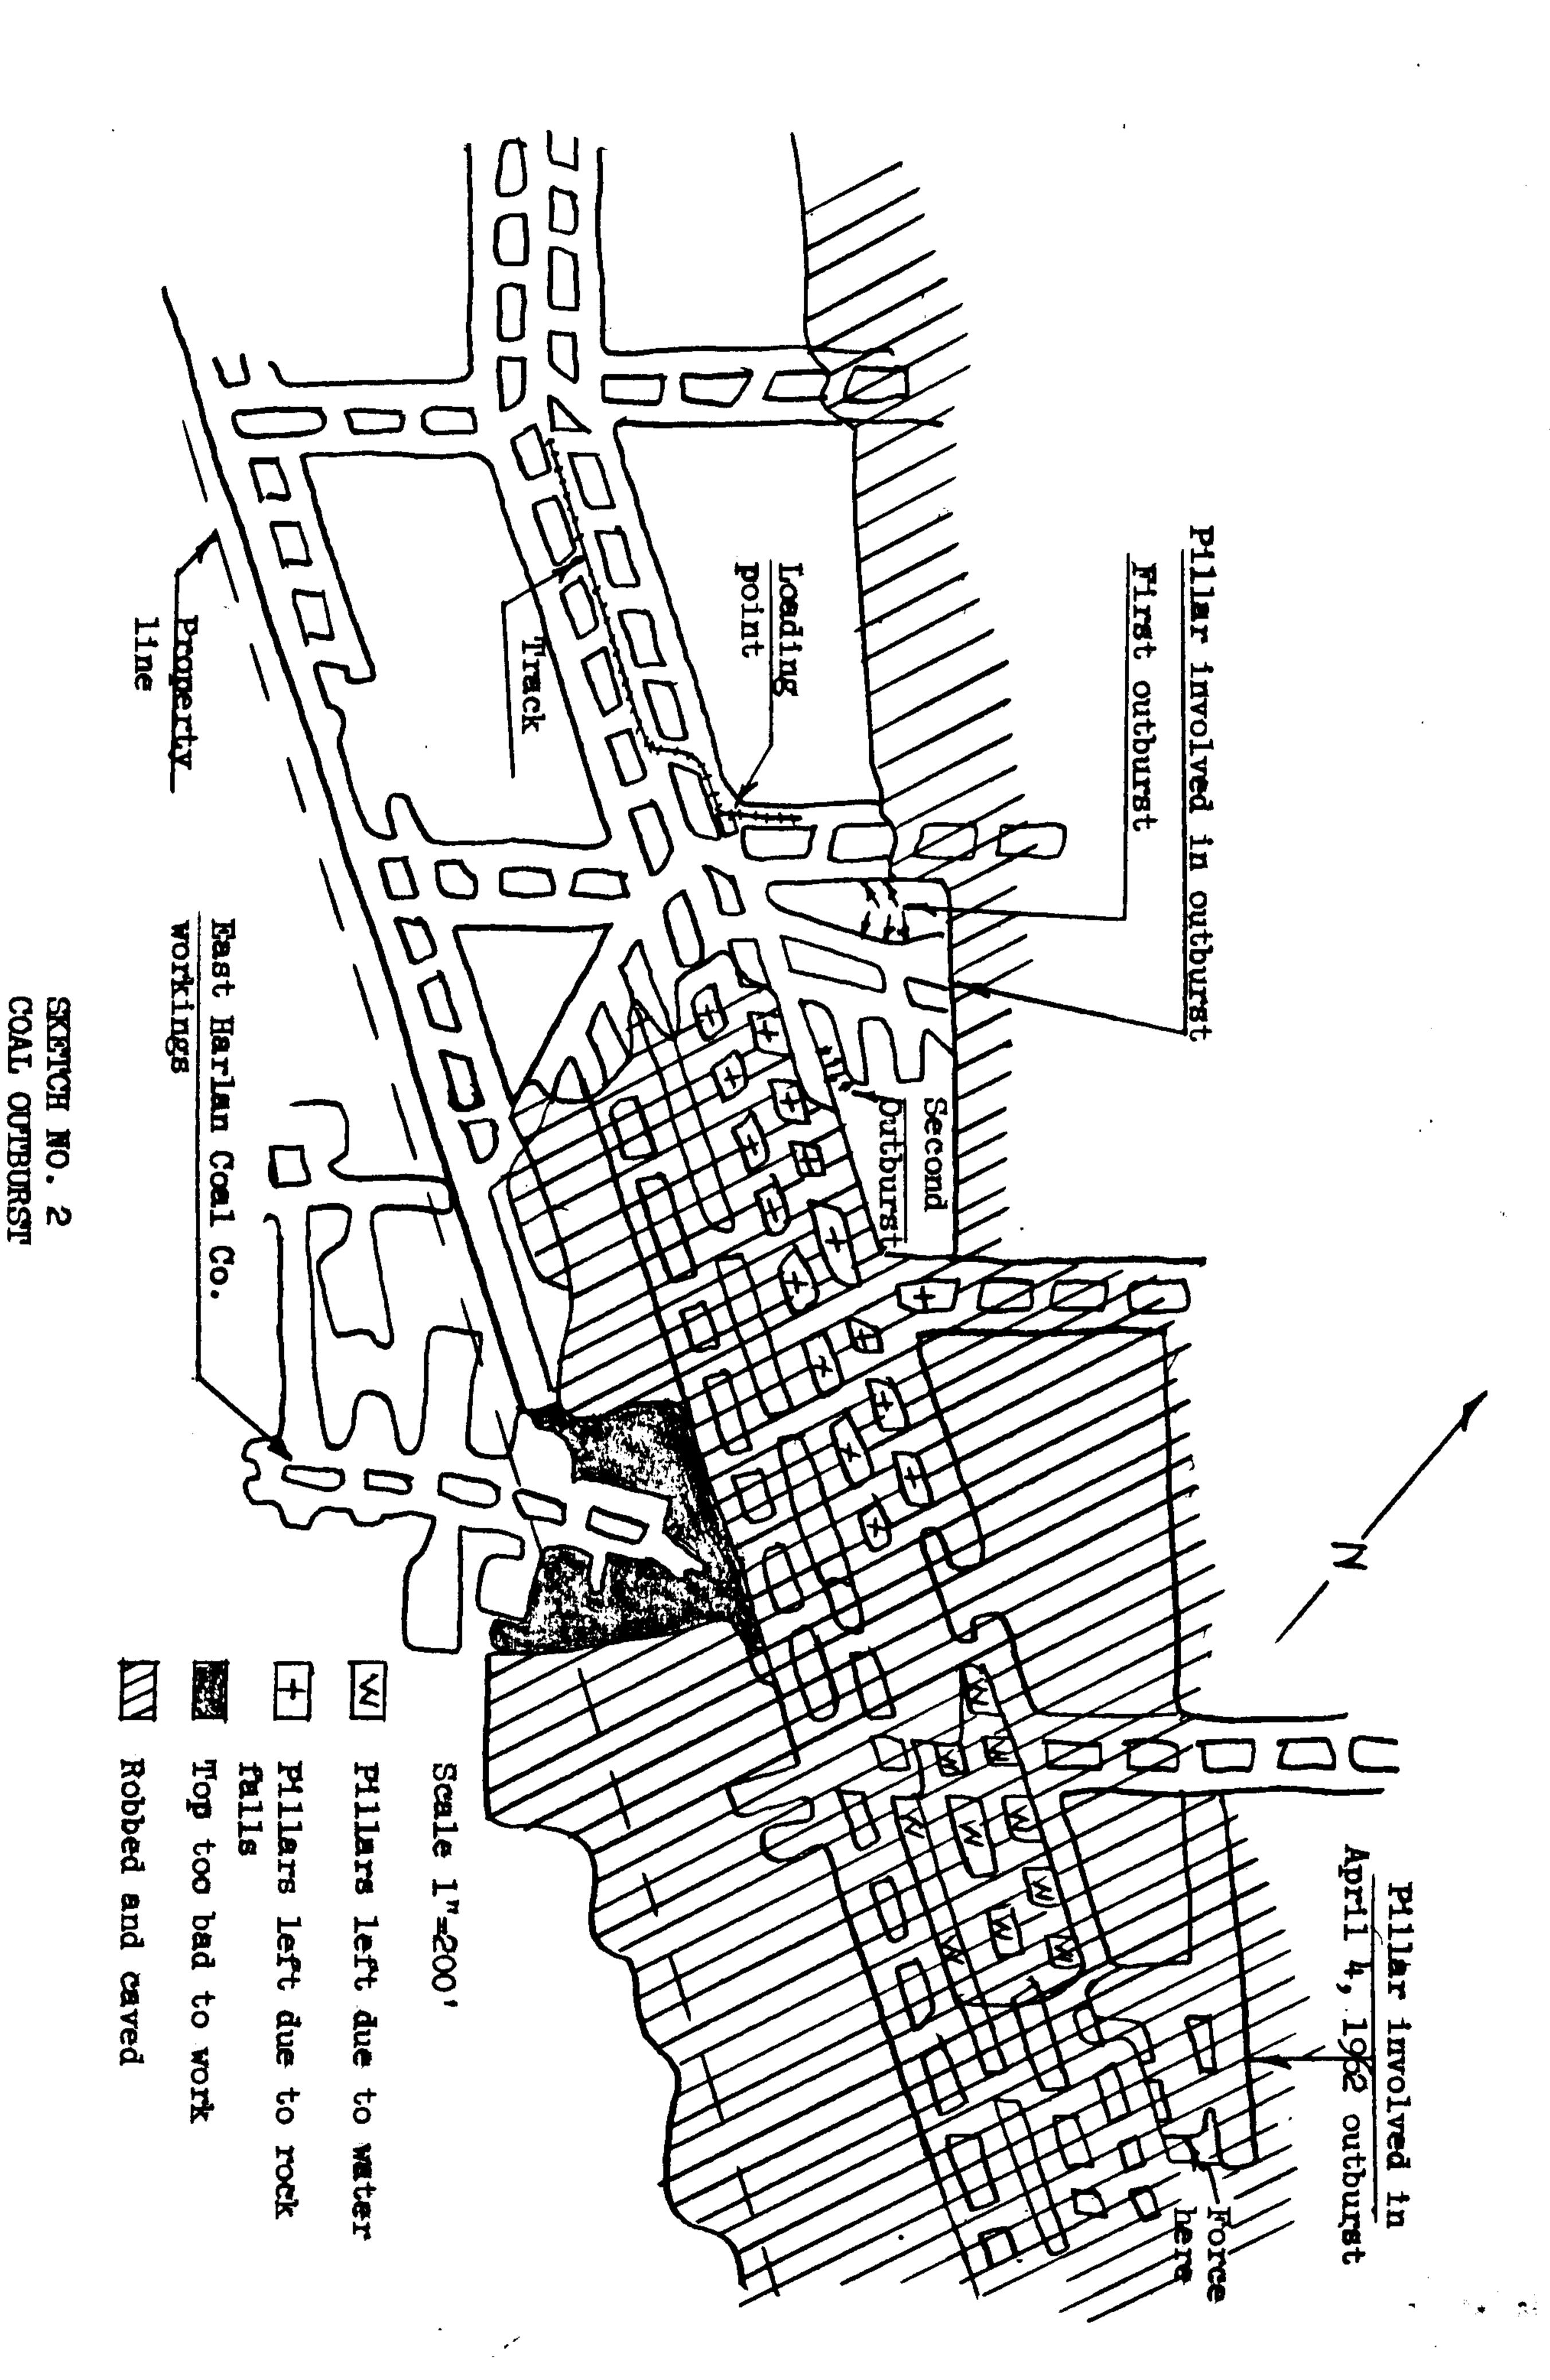
All mining in K main section was confined to the recovery of entry chain pillars and the flanking barrier pillars (see sketch No. 2). The barrier pillars, formed during the development of the K main section, were of decidedly unequal deminsions and each one created a different problem during extraction.

1. The pillars should be recovered by the open-end lift method; however, where roof conditions present a hazard, a thin wing or fender is permissible. The lifts should be driven so that each lift and adjacent consecutive lifts will be mined along the gob sides of the pillars. Only one lift, not more than 16 feet wide, should be mined at one time.
